NASA TECHNICAL NOTE

NASA TN D-4916

POSTFLIGHT OPTICAL EVALUATION OF THE RIGHT-HAND AND LEFT-HAND WINDOWS OF GEMINI MISSIONS IV, V, VI, AND VII

Manned Spacecraft Center Houston, Texas

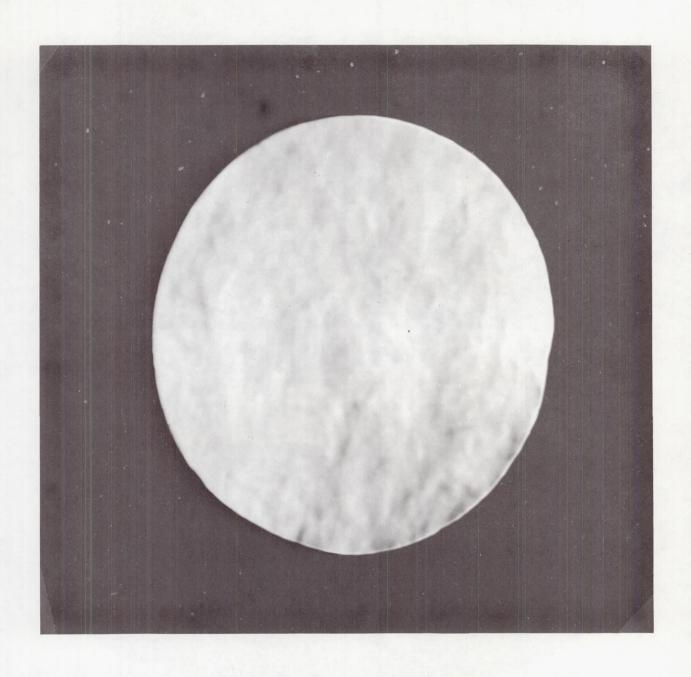
Figure 6. - Schlierengraph field of view with horizontal knife edge.

Schlieren. - Results of the schlieren study are shown in schlierengraphs (figs. 6 to 9). Figure 6 shows the uniform field of the open schlieren. Figures 7(a), 8(a), and 9(a) show the clean right windows inserted into the beam. Figure 7(b) (the G-V left window) shows a material flaw in the lower right-hand corner. The dark areas in figures 7(b), 8(b), and 9(b) (the G-V, G-VI, and G-VII clean left windows) are caused by either a wedge angle and/or a deviation from surface flatness.

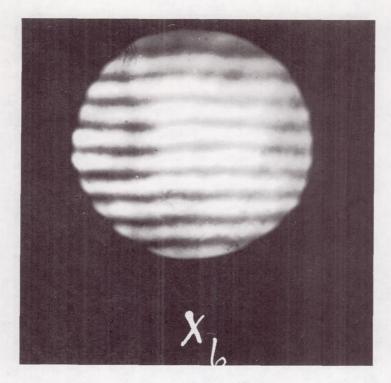
Interferometer. - Interferograms of the right windows are shown in figures 15(a), 16(a), 17(a), and 18(a); and the interferograms of the left windows are shown in figures 15(b), 16(b), 17(b), and 18(b). Wave-front deviation ranged from 0.2 to 1 wave for the right windows, and from 1 to 14 waves for the left windows. The maximum and average deviations for each window are presented in table VII. The values given are relative to the mercury green line at 546.1 m μ .
